PENNSYLVANIA  
NDS ID PA. 00669  
DER ID 54-67

# KUNKLES DAM

## PHASE I INSPECTION REPORT NATIONAL DAM INSPECTION PROGRAM

JUNE 1980

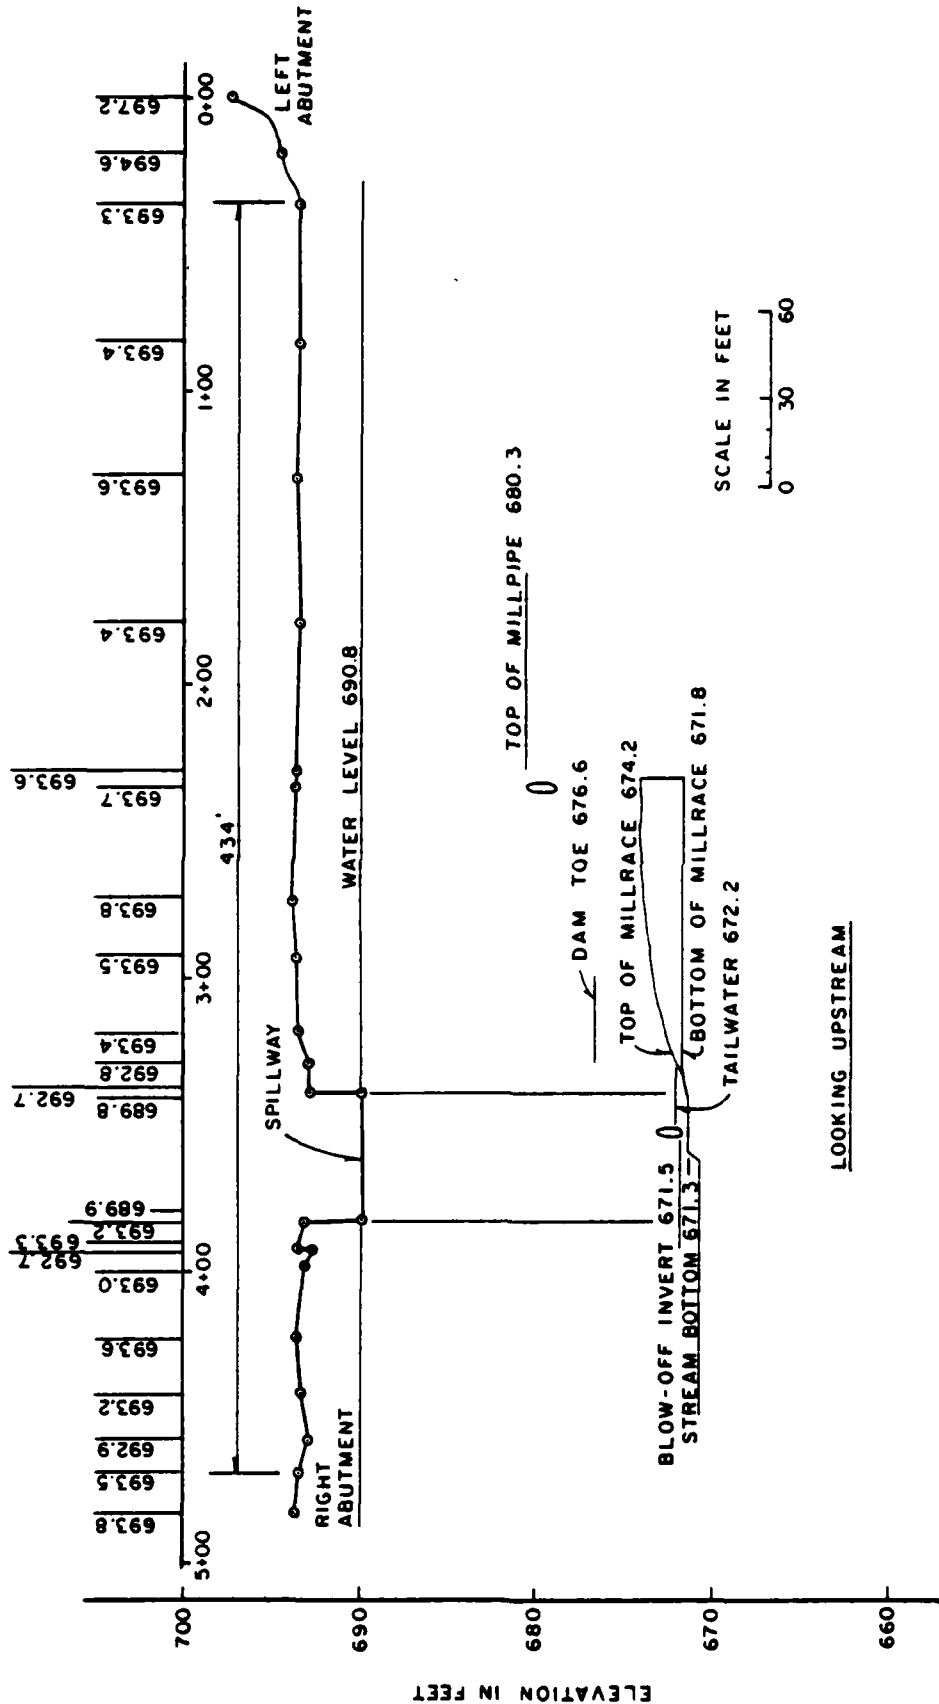
SHEET 58 OF 11

b. Dam. The vertical alignment of the dam crest was checked, and the profile is shown on sheet 5B, Appendix A. Although the vertical profile is uneven, there are no distortions in alignment that would be indicative of deep-seated movement of the embankment or foundation. The minimum crest elevation is about 0.6 feet below the right spillway wall. The upstream slope below the waterline appears to be earth with shale fragments. It is possible that this overlies paving, according to the 1915 report in Department of Environmental Resources files. Above the waterline, the embankment ranges from nearly vertical to about 2.5H:1V. Brush and trees are growing at the waterline in many places, as shown in Photographs 5 and 6. Waves have benched the upstream slope and have undercut the slope under a tree at the upstream side to the right of the spillway. The crest of the dam ranges from 8 to 12 feet in width and is protected with grass and shale fragments. Swales have been worn by foot traffic and/or erosion over the upstream edge of the crest. The downstream slope consists of a dry masonry wall, shown in Photograph 7, which was constructed after the dam was built, from the spillway to a point about 90 feet left of the spillway. Either the height of this wall decreases towards the left or rock fill has been placed at the base of the wall. Elsewhere, the downstream slope ranges from vertical to about 1.8H:1V to 2.0H:1V. The downstream slope is generally covered with rock fill which is loose and slides underfoot. However, between the end of the downstream masonry wall and the left abutment, shown in Photograph 8, the surficial embankment materials contain more soil, permitting grass to grow on the embankment. About halfway between the end of the vertical wall and the left abutment, stone steps were constructed up the face of the dam, but foot traffic has worn paths over the downstream face of the dam. Several large trees, ranging between one and two feet in diameter, are also growing on the downstream slope of the embankment. In the vicinity of the left abutment, the downstream slope is uneven as a result of the attempt to lower the embankment crest during Tropical Storm Agnes, June 1972.

FIELD OBSERVATION PROFILE  
KUNKLES DAM
